INDOOR AIR QUALITY ASSESSMENT

**Old Hammondtown Elementary School
20 Shaw Street
Mattapoisett, Massachusetts**

Prepared by:
Massachusetts Department of Public Health
Bureau of Environmental Health Assessment
January 2004

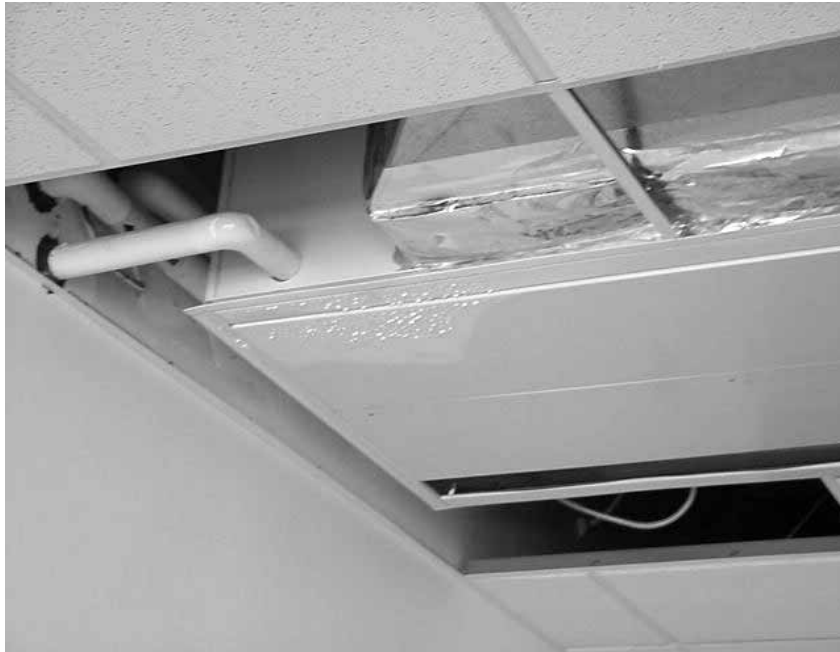
Picture 1

The building was evaluated on a warm day, with an outdoor temperature of 83°F and relative humidity of 60 percent. The last recorded rainfall in the OHES area occurred August 17, 2003 (Weather Underground, 2003), five days prior to this assessment. Condensation droplets were noted on unit ventilator (univent) cabinets (Picture 1), chilled water pipe hangers (Picture 2), pipe insulation and other building components. It appeared that the HVAC chilling system had its temperature setting lowered in an effort to reduce water vapor concentrations in the building. Surface temperature of univent coils ranged between 32° F to 64 ° F (Table 1).

There appear to be several sources of moisture generating condensation. The primary source appeared to be introduction of moisture into the building through the univents. When warm, moist air passes over a surface that is colder than the air, water condensation can collect on the cold surface. Over time, water droplets can form, which can then drip from a suspended surface. For this reason, HVAC systems are equipped with drainage systems beneath cooling coils to drain condensate as moist outdoor air is cooled. Univents have light plastic drip pans. When overfilled with water, these drain pans will tend to distort shape, creating a bowl effect, thus preventing drainage and resulting in a pooling effect. Condensation drains in some univents were spot checked and found to be overfilled, which prevent water from reaching the holes that lead to PVC pipe that directs water outside the building. Water flow from the PVC pipe drains was found to be draining minimally (Picture 3) or not at all (Picture 4). As univent air flows over this pooled water in the condensation pans, moisture is reintroduced into each classroom without lower relative humidity.

Condensation Droplets Were Noted On Unit Ventilator (Univent) Cabinets

1. Reactivate dehumidifiers. Have dehumidifiers operate to empty water into the plumbing drainage system or to direct water outdoors.
2. Reactivate the exhaust ventilation system to remove water vapor from the building.
3. Limit the amount for fresh air introduced into the building by univent operation.
4. Raise the temperature within the building to decrease condensation on building components above the dew point. Prior to increasing temperature, contact the manufacturer of univents to ascertain the appropriate procedure to raise the temperature to prevent cracking of coils that had temperatures below freezing.

1. Deactivate the air-conditioning system until control of condensation from this HVAC system is achieved. Continue to consult with a ventilation engineer concerning appropriate measures to control condensation generated by the air-conditioning system.
2. Ascertain whether moistened building components had become mold colonized. If mold colonized, remediate mold contaminated building materials in a manner consistent with *Mold*

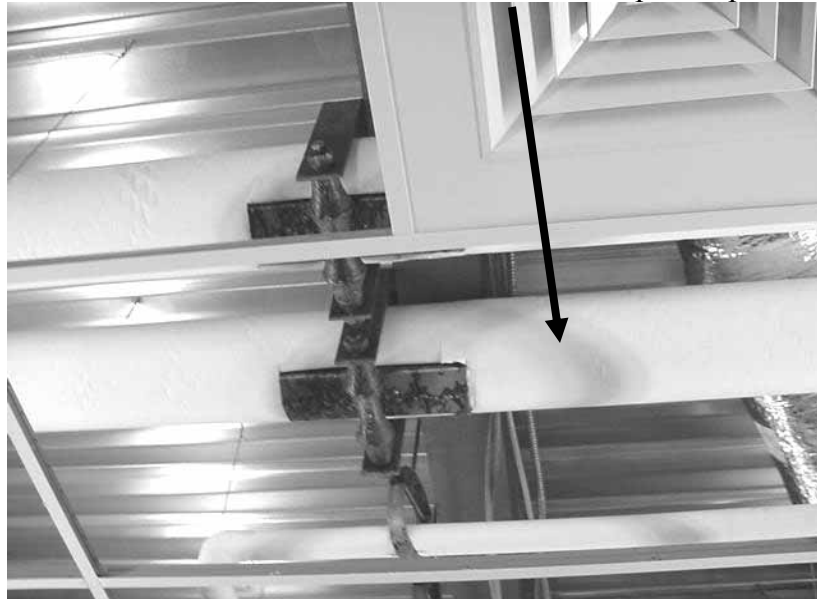
Picture 2

Pipe insulation that is moistened for an extended period of time can result in several problems. The exterior wrap is made of a paper material that, if not dried, can serve a medium for mold growth. In addition, wetting of insulation can degrade its performance, resulting in increased energy costs. Lastly, condensation occurs if spaces in the insulation exist or the R rating of the insulation is not sufficient. Spaces between insulation sections can allow moist air to be exposed to the metal of the chilled water pipes, which results in condensation. The R rating is a mathematical representation of the ability of insulation to prevent temperature transfer. If an air conditioning system has chilled water pipes with an insufficient R rating, temperature could be transferred to the surface paper, thus creating condensation. Once water wets insulation, a temperature bridge is created, which results in further wetting of insulation and enhancing mold growth.

Water Stain in Pipe Wrap

Chilled Water Pipe Hangers (Note Rust And Water Staining)

3. Consider consulting a building engineer to determine the extent of the effect of water damage to chilled water pipe and univent insulation. Remediate as needed.
4. Ensure that univent drain pans in univents to properly drain condensation.

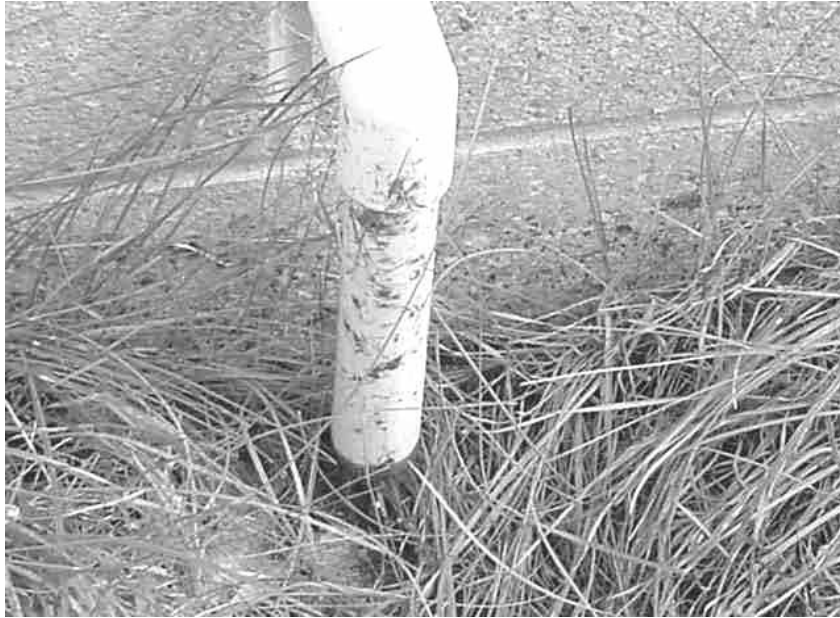
Picture 3

Minimal Drainage of Condensation from a Univent Drip Pan Drain

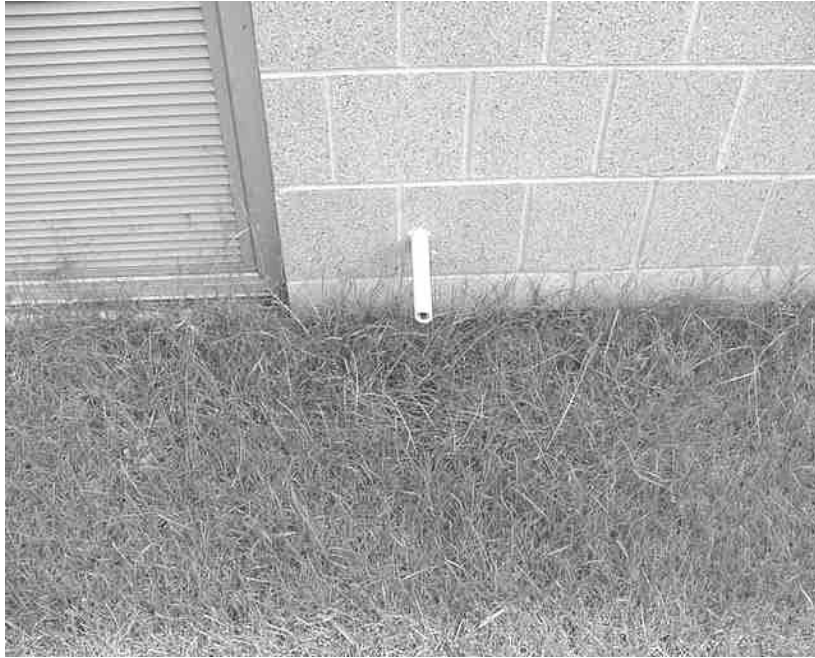
Picture 4

No Drainage of Condensation from a Univent Drip Pan Drain

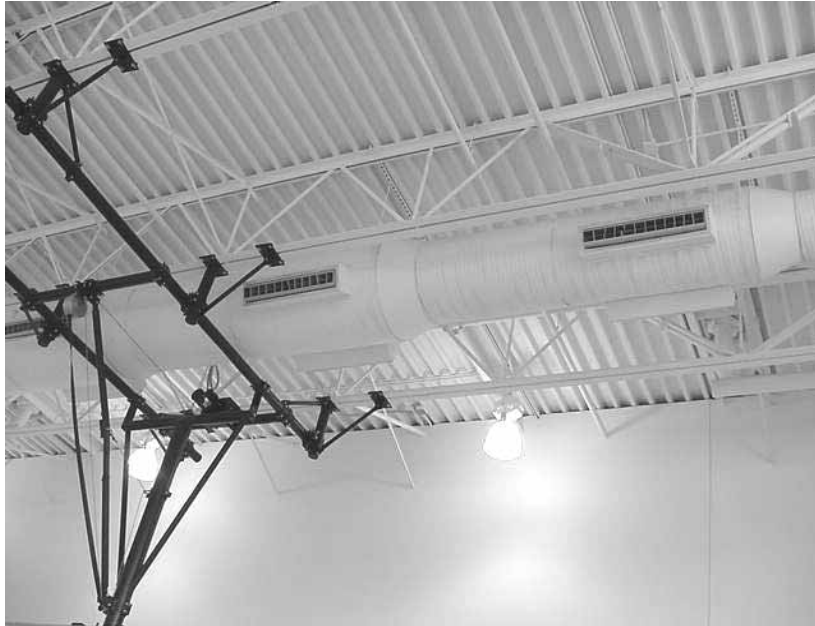
Picture 5

F and relative humidity of 60%, the dew point necessary for water to collect on a surface is 68 ° F. Surface temperatures measured in most areas with active, chilled air ventilation were equal to or below the dew point on August 22, 2003. Any surface inside the OHES that had a temperature at or below 68 ° F would generate condensation. The surface temperatures for a variety of building components were measured in a number of areas throughout the OHES (Table 1). The surface temperature of pipe insulation, pipe hanger, univent cabinets a gypsum wallboard (GW) was significantly below the outdoor dew point. The temperatures of building components caused condensation generation, which moistened these materials. Please note that gymnasium ductwork, which was not operating and had a temperature above the dew point, was not generating condensation (Picture 5).

Gymnasium Duct Free of Condensation
